# FS Condensation on Back of Profile

Service Solution

Skylight looks like it is leaking even when it is not raining.

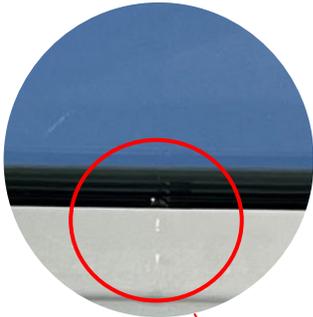
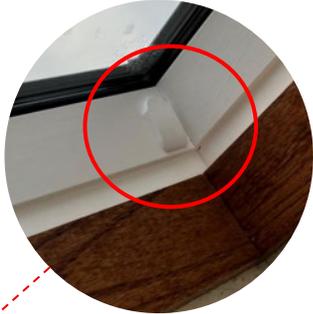
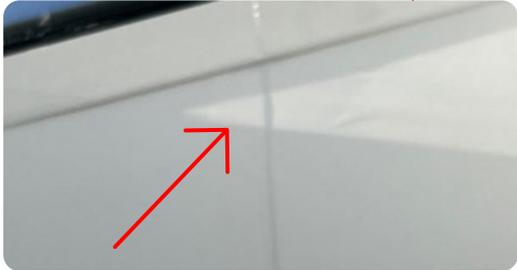
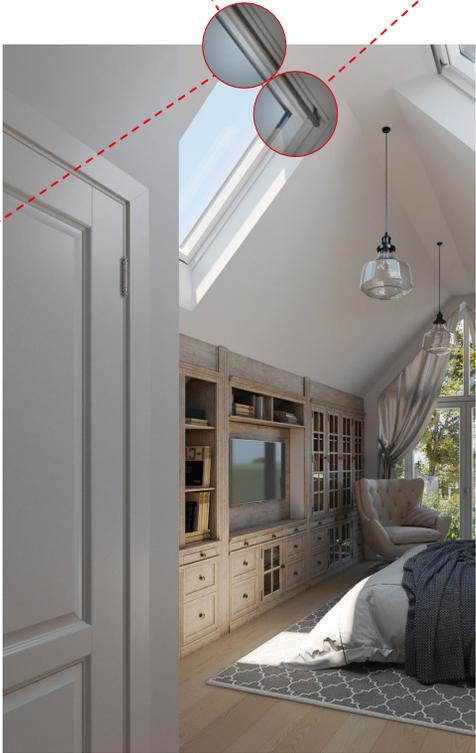
1

Confirm the issue.

**Description of problem:**

Interior warm and moist air can get behind gaskets on FS skylights, causing condensation to form on the underside of the top profile.

This may result in water dripping in at the top of the skylight or around the blind clip.

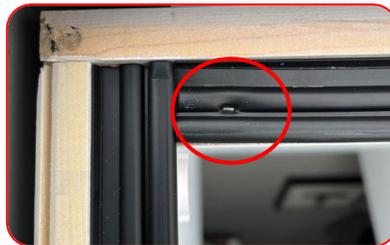
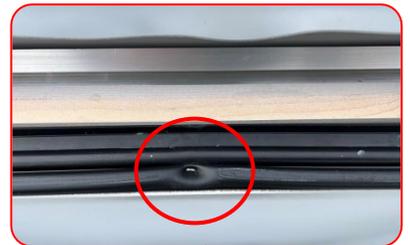
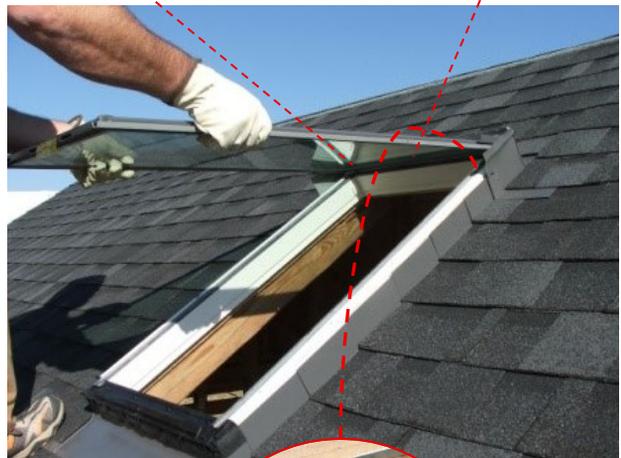
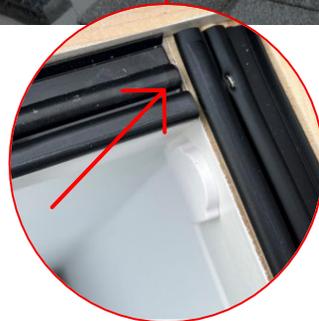
2

Identify the cause.

### Potential causes of the problem:

1. Incorrectly positioned gasket staples, creating a path for warm air to enter the same cavity
2. Gaskets being cut too short in the corners, allowing warm air to enter the cavity of the top profile

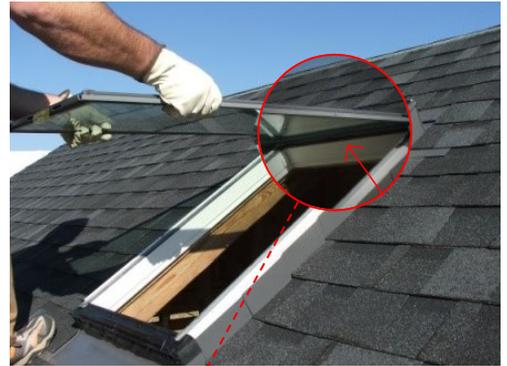
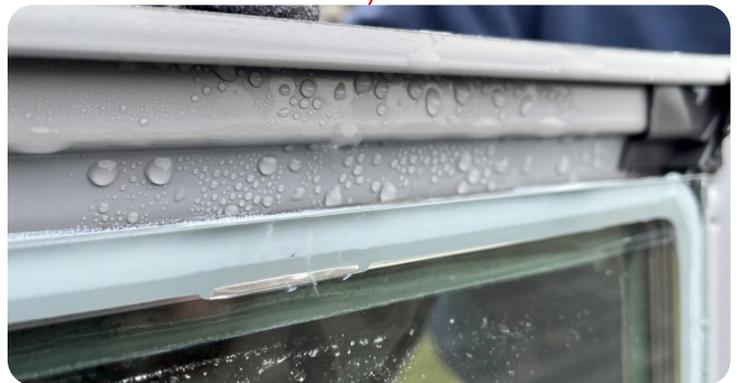
3

### Symptoms:

Excessive condensation can form within the profile cavity of the skylight, particularly during cold weather or in a humid environment, causing water to drip onto the gasket.

The gasket is designed to divert the condensation to the sides. If the gasket is short, it can drip through gaps or around the blind clips.

If the gasket is stapled incorrectly, it will likely drip at that point.
